**This MotoCAP safety rating applies to:**

**Brand:** DriRider  
**Model:** Apex 5 Ladies  
**Type:** Jacket - Textile  
**Date purchased:** 16 November 2019  
**Sizes tested:** 14 and 18  
**Gender:** F  
**Style:** Tourer  
**Test code:** J19T35

**Test Results Summary:**

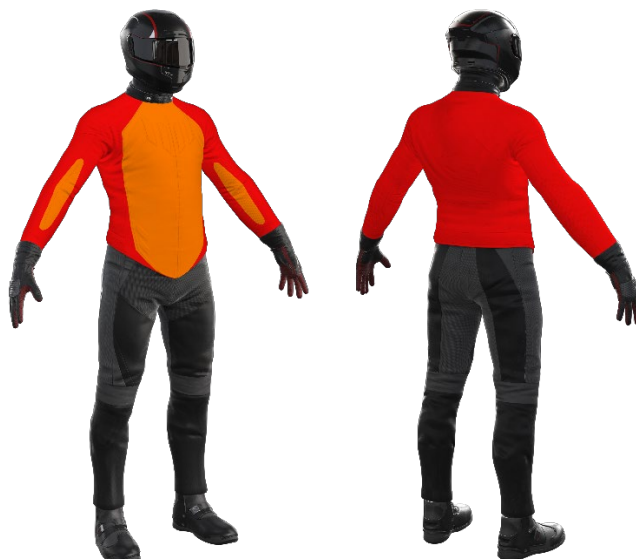
Zone	Coverage (%)	Abrasion time for each test (seconds)						Average (seconds)	
		1	2	3	4	5	6		
<b>Zone 1 and 2 areas (High abrasion risk)</b>									
Material A	90%	3.31	1.95	2.60	2.52	2.40	3.48	2.71	M
Material B	10%	0.73	0.80	0.52	0.52	0.70	0.45	0.62	P
<b>Zone 3 area (Medium abrasion risk)</b>									
Material B	100%	0.73	0.80	0.52	0.52	0.70	0.45	0.62	P
<b>Zone 4 area (Low abrasion risk)</b>									
Material B	100%	0.73	0.80	0.52	0.52	0.70	0.45	0.62	M

The diagram below is a visual indication of the likely abrasion performance of the materials in each zone calculated from the data in the table above. The colour coding is based on the worst performing material in each zone.

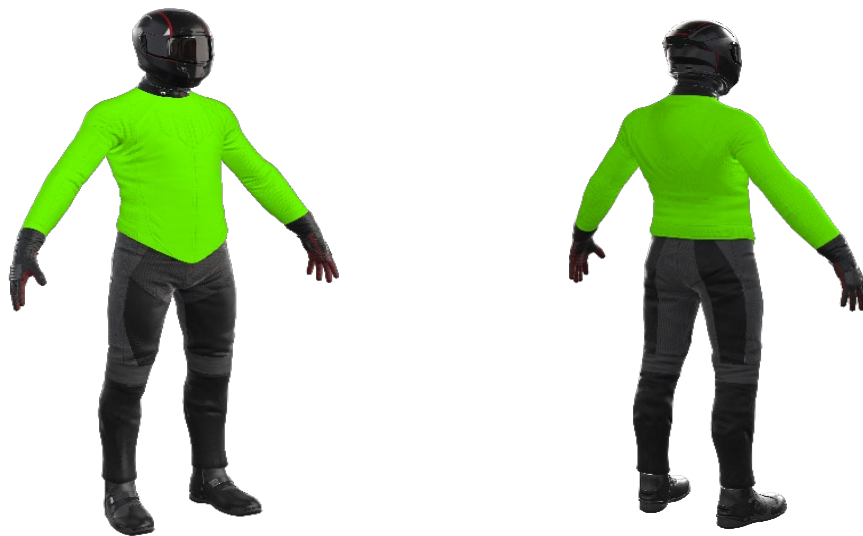
Area	1	2	3	4	5	Average	
Zones 1 & 2	1946	1956	1948	1525	1129	1701	G
Zone EZ	1436	1503	823	1008	1266	1207	G
Zones 3 & 4	1411	976	1113	1046	633	1035	G

The diagram below illustrates the burst strength results in terms of the likely performance of the garment in an impact and is a pictorial representation of the data from the table above.

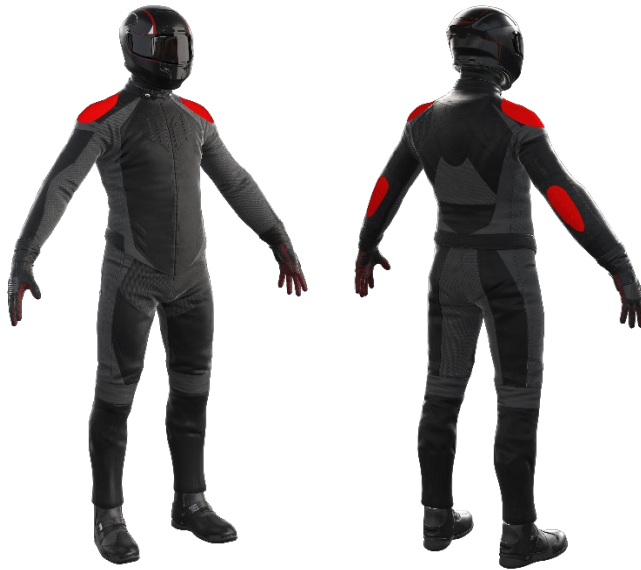
Impact protector type	Elbow		Shoulder	
Average force (kN)	28.3	M	28.0	M
Maximum force (kN)	39.0	P	38.7	P
Coverage of zone 1 area	80%		100%	
Coverage of zone after displacement	100%		100%

The diagram below is a visual indication of the likely performance of each impact protector calculated from the data in the table above. The colour coding is based on the worst performing score for average or maximum force for each impact zone.
