**This MotoCAP safety rating applies to:**

| Brand | Blackbird |
| Model | Savanna |
| Type | Jacket - Textile |

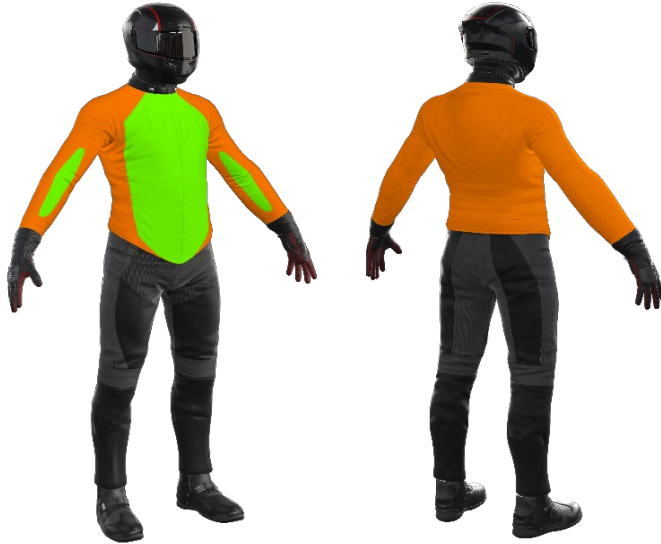
The jacket was tested for abrasion resistance in accordance with MotoCAP test protocols. The diagram below is a visual indication of the likely abrasion performance of the materials in each zone calculated from the data in the table below. The colour coding is based on the worst performing material in each zone.

| Abrasion rating | 2/10 |
| Abrasion score | 1.73 |

| Zone 1 & 2 | Coverage (%) | Sample 1 | Sample 2 | Sample 3 | Sample 4 | Sample 5 | Sample 6 | Average | |
|---|---|---|---|---|---|---|---|---|---|
| Material A | 100% | 2.12 | 1.77 | 1.60 | 1.99 | 1.41 | 1.52 | 1.73 | M |
| Material A | 100% | 2.12 | 1.77 | 1.60 | 1.99 | 1.41 | 1.52 | 1.73 | G |

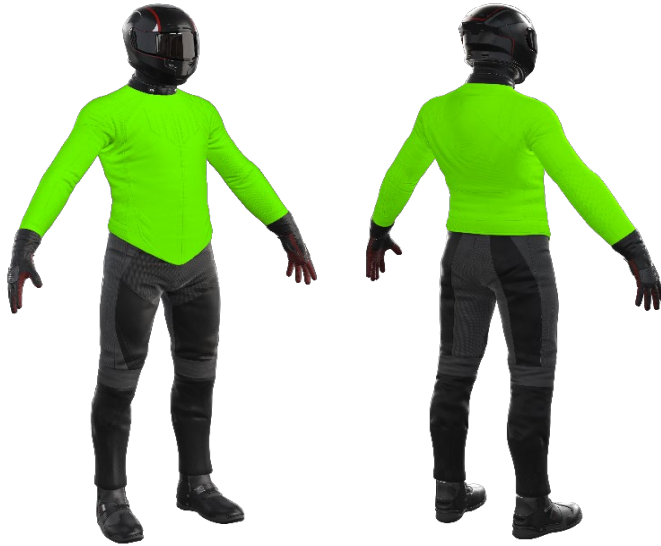
The jacket was tested for burst strength in accordance with MotoCAP test protocols. The diagram below illustrates the burst strength results in terms of the likely performance of the garment in an impact and is a pictorial representation of the data from the table below.

| Burst rating | 10/10 |
| Burst score | 1098 |

| Area | Sample 1 | Sample 2 | Sample 3 | Sample 4 | Sample 5 | Sample 6 | Average | |
|---|---|---|---|---|---|---|---|---|
| Zones 1 & 2 | 764 | 1503 | 788 | 1057 | 1495 | 1130.3 | 1123 | G |
| Zones 3 & 4 | 1051 | 1145 | 1011 | 852 | 1092 | 849.3 | 1000 | G |
