This MotoCAP safety rating applies to:

Brand Macna Model Adept

Type Jacket - Textile
Date purchased 5 December 2022

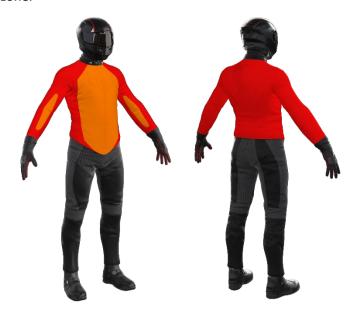
Abrasion Resistance Performance

The jacket was tested for abrasion resistance in accordance with MotoCAP test protocols. The diagram below is a visual indication of the likely abrasion performance of the materials in each zone calculated from the data in the table below. The colour coding is based on the worst performing material in each zone.

Abrasion rating	1/10
Abrasion score	0.71

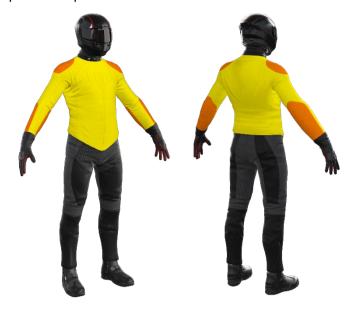
The jacket was tested for burst strength in accordance with MotoCAP test protocols. The diagram below illustrates the burst strength results in terms of the likely performance of the garment in an impact and is a pictorial representation of the data from the table below.

Burst Strength Performance					
Burst rating	6/10				
Burst score	635

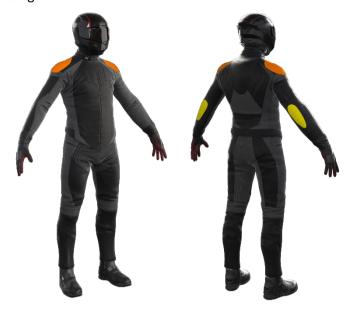
Impact Protection Performance

The jacket was tested for impact protection and coverage in accordance with MotoCAP test protocols. The diagram below is a visual indication of the likely performance of each impact protector calculated from the data in the table below. The colour coding is based on the worst performing score for average or maximum force for each impact zone. Areas shaded black are not considered for impact protection ratings.

Impact rating	7/10
Impact score	54.4

Impact protector type	Elbow		Shoulder
Average force (kN)	20.1	A	21.8 A
Maximum force (kN)	23.6	A	25.2 M
Coverage of Zone 1 area	150%		130%
Coverage of Zone after displacement	100%		100%

This garment is fitted with impact protectors for the elbows and shoulders. Pockets are provided at chests and back for fitting aftermarket impact protectors. Replacing the shoulder armour with higher performing impact protectors would improve the protection levels of this garment. There are zipped vents in the sides and mesh panels in the upper back to allow controlled airflow movement through the garment. The breathability rating is based on tests of the garment's materials when all vents are closed. The breathability of this product may be better when the vents can be opened. Breathability was measured without the removable thermal liner installed.
