This MotoCAP safety rating applies to:

Brand	Merla Moto
Model	Denver Checked Wool
Type	Jacket - Textile
Date purchased	4 December 2024
Sizes tested	XL and 2XL
Test garment gender	Male
Style	All Purpose
RRP	\$299.00

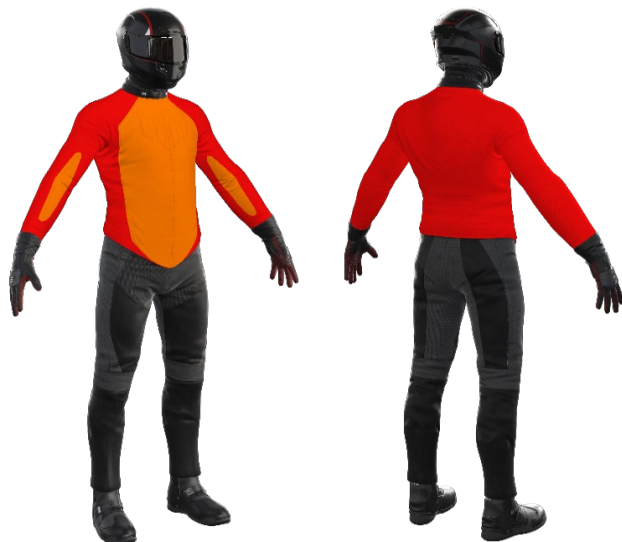
Abrasion Resistance Performance

The jacket was tested for abrasion resistance in accordance with MotoCAP test protocols. The diagram below is a visual indication of the likely abrasion performance of the materials in each zone calculated from the data in the table below. The colour coding is based on the worst performing material in each zone.

Abrasion rating	1/10
Abrasion score	0.64

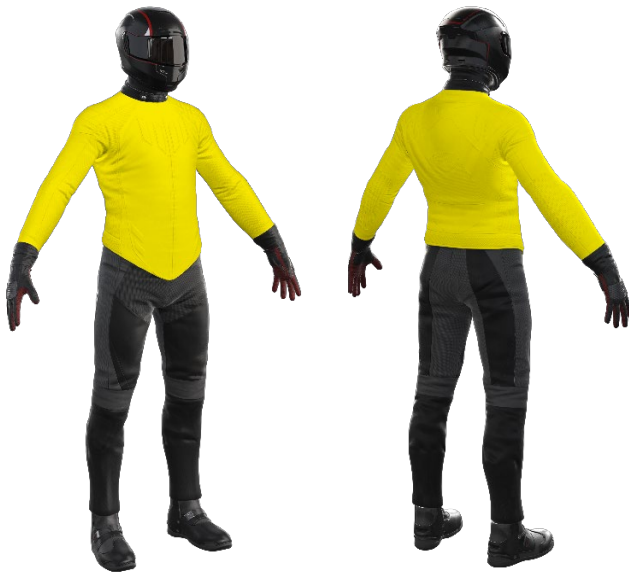
Burst Strength Performance

The jacket was tested for burst strength in accordance with MotoCAP test protocols. The diagram below illustrates the burst strength results in terms of the likely performance of the garment in an impact and is a pictorial representation of the data from the table below.

Burst rating	9/10
Burst score	909

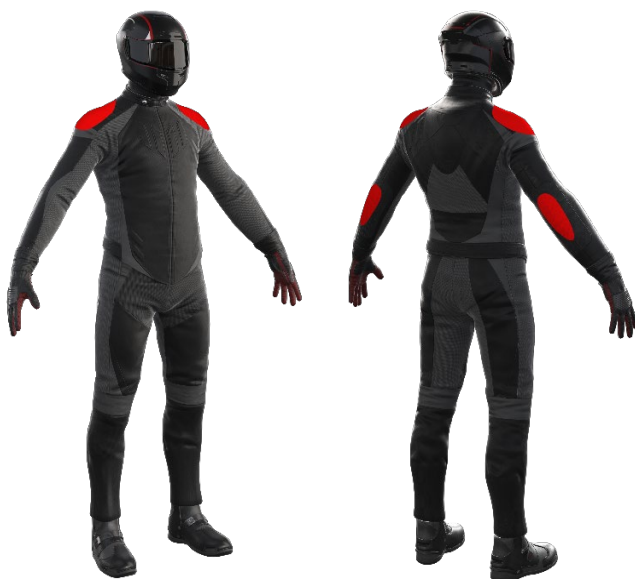
Impact Protection Performance

This jacket was not tested for impact protection as impact protectors were not provided with the garment. The diagram below is a visual indication of the likely performance of each impact protector calculated from the data in the table below. The colour coding is based on the worst performing score for average or maximum force for each impact zone. Areas shaded black are not considered for impact protection ratings.

Impact rating	1/10
Impact score	0.0

Pockets are provided at the shoulders, elbows and back for fitting aftermarket impact protectors. Adding elbow and shoulder impact protectors would improve the protection levels of this garment. There are no vents to allow airflow movement through the garment.
