This MotoCAP safety rating applies to:

Brand	Klim
Model	Badlands Pro
Type	Pants - Textile
Date purchased	25 October 2019
Sizes tested	34 and 36
Test garment gender	Male
Style	All Purpose
RRP	$1,195.00

Brand	Klim
Model	Badlands Pro
Type	Pants - Textile
Date purchased	25 October 2019
Tested by	AMCAF, Deakin University
Garment test reference	P19T12
Rating first published	September 2020
Rating updated	3 September 2020

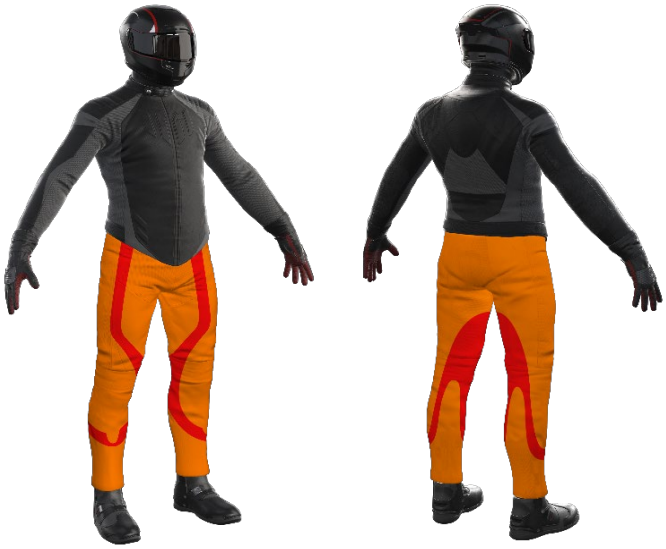
These pants were tested for abrasion resistance in accordance with MotoCAP test protocols. The diagram below is a visual indication of the likely abrasion performance of the materials in each zone calculated from the data in the table below. The colour coding is based on the worst performing material in each zone.

Abrasion Resistance Performance	
Abrasion rating	3/10
Abrasion score	2.15
