This MotoCAP safety rating applies to:

Brand	Klim
Model	Carlsbad
Type	Pants - Textile
Date purchased	17 May 2021
Sizes tested	36 and 40
Test garment gender	Male
Style	Tourer
RRP	$845.00

Assessment Details.

Brand	Klim
Model	Carlsbad
Type	Pants - Textile
Date purchased	17 May 2021
Tested by	AMCAF, Deakin University
Garment test reference	P20T12
Rating first published	October 2021
Rating updated	18 October 2021

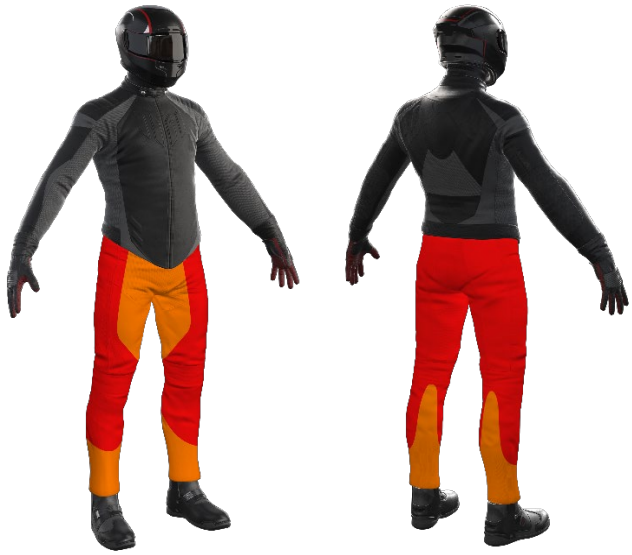
These pants were tested for abrasion resistance in accordance with MotoCAP test protocols. The diagram below is a visual indication of the likely abrasion performance of the materials in each zone calculated from the data in the table below. The colour coding is based on the worst performing material in each zone.

Abrasion Resistance Performance	
Abrasion rating	2/10
Abrasion score	1.60

Zones 1 & 2	Coverage (%)	Sample 1	Sample 2	Sample 3	Sample 4	Sample 5	Sample 6	Average	
Material A	85%	1.24	1.25	1.78	1.45	3.95	3.39	2.18	M
Material B	15%	0.34	0.35	0.68	0.40	0.79	0.97	0.59	P
Zone 3	Coverage (%)	Sample 1	Sample 2	Sample 3	Sample 4	Sample 5	Sample 6	**Average**	
Material C	20%	9.01	8.85	6.92	9.68	0.00	0.00	8.62	G
Material B	80%	0.34	0.35	0.68	0.40	0.79	0.97	0.59	P
Zone 4	Coverage (%)	Sample 1	Sample 2	Sample 3	Sample 4	Sample 5	Sample 6	**Average**	
Material D	50%	1.28	1.77	0.77	1.17	0.00	0.00	1.25	A
Material B	50%	0.34	0.35	0.68	0.40	0.79	0.97	0.59	M

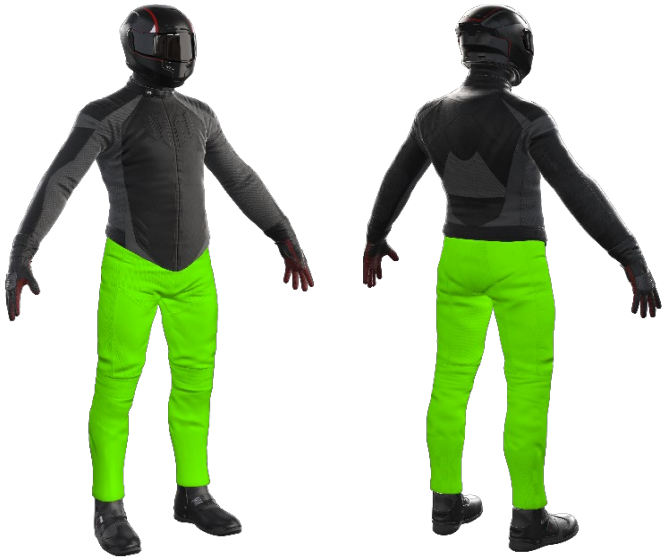
These pants were tested for burst strength in accordance with MotoCAP test protocols. The diagram below illustrates the burst strength results in terms of the likely performance of the garment in an impact and is a pictorial representation of the data from the table below.

Burst Strength Performance	
Burst rating	10/10
Burst score	1349

Area	Sample 1	Sample 2	Sample 3	Sample 4	Sample 5	Sample 6	Average	
Zones 1 & 2	1089	1615	1268	1171	1227	1403	1295	G
Zones 3 & 4	987	1319	1871	1643	1708	1857	1564	G

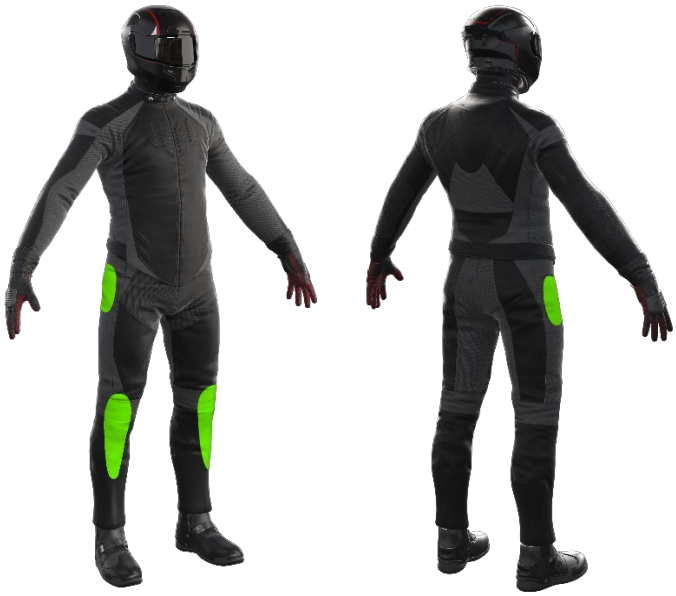
These pants were tested for impact protection and coverage in accordance with MotoCAP test protocols. The diagram below is a visual indication of the likely performance of each impact protector calculated from the data in the table below. The colour coding is based on the worst performing score for average or maximum force for each impact zone. Areas shaded black are not considered for impact protection ratings.

Impact Protection Performance	
Impact rating	9/10
Impact score	67.5

Impact protector type	Knee		Hip	
Average force (kN)	9.6	G	9.7	G
Maximum force (kN)	10.5	G	10.3	G
Coverage of Zone 1 area	110%		115%	
Coverage of Zone after displacement	70%		100%
